90R Splicer Error Code and Troubleshooting Quick Guide

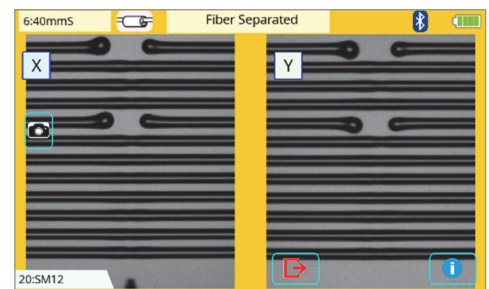
Figure 2

Fiber Separated error occurs when the fibers burn back rather than fusing together. (**Figure 2**).

- Often, this results from using the wrong type of fiber for performing an arc calibration. This can make the standard arc power too powerful, causing fiber separation.
- Perform an Arc Calibration only with standard G.652 SMF for arc calibration.
 - If the error persists or is limited to a particular splice mode, call the 24/7 support line at 1-800-235-3423, Opt. 3.

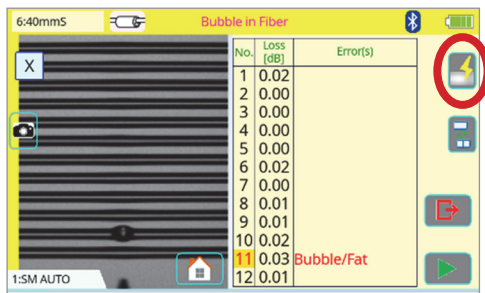
Figure 7

Bubble errors indicate a deformity is detected at the splice point, usually arising from contamination on the fiber end-face or from a bad cleave shape.

- A true bubble will appear as a dark circle at the splice point. Verify it is a bubble by pressing the **Re-Arc** button after the splice. If the occlusion changes or the spot grows, then it is a bubble. Break and re-splice (**Figure 7**).
 - Be sure to follow the proper “Strip, Clean, Cleave” preparation procedure. If the cleave shape is an issue, refer to the “Cleave Shape NG” section above.
- A Bubble error can sometimes arise when splicing highly multimode fibers, especially. This is the result of air becoming trapped in the glass as the two fibers begin to melt together. In this event, break and re-splice (see **red arrow** in **Figure 8**). This line does not affect splice loss, and the Bubble error can be handled by adjusting the “Bubble Sensitivity” setting in the splice mode.

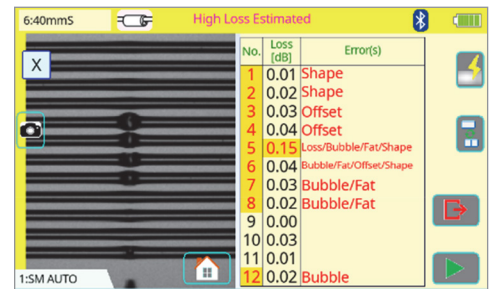
Figure 9

High Estimated Loss error could arise from many causes of this error, including the following (**Figure 9**):

- Improper fiber cleaning
- Bad fiber end face
- Bubble at the splice point
- Dust or dirt in the V-groove
- Dust or debris on the camera lens
- Bad electrode condition
- Uncalibrated arc power
- Incorrect splice mode
- Improper arc parameters
- Inadequate estimation parameters

NOTE: Consult the Instruction Manual for assistance with correcting these issues.
