90R Splicer Error Code and Troubleshooting Quick Guide

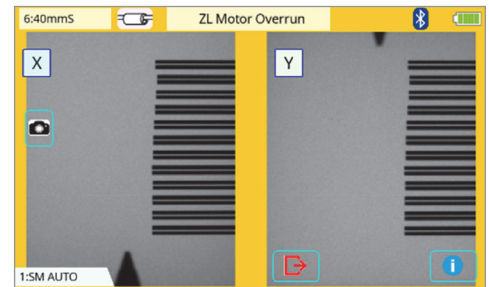
Figure 1

ZL/ZR Motor Overrun means the motor ran to its full extent, but the fiber position is not correct (**Figure 1**).

- Either the cleave length is too short or a loose buffer tube is preventing the splicer from pulling the fiber(s) into the center.
- Make sure the end of the fiber(s) is between the edge of the V-groove and the center between the electrodes. If there is a loose buffer tube present, use the FH-60-LT900 fiber holder to keep the fiber from sliding within the buffer tube.

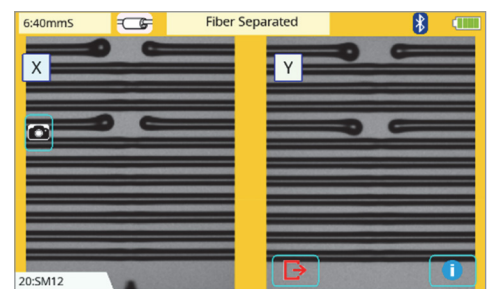
Figure 2

Fiber Separated error occurs when the fibers burn back rather than fusing together. (**Figure 2**).

- Often, this results from using the wrong type of fiber for performing an arc calibration. This can make the standard arc power too powerful, causing fiber separation.
- Perform an Arc Calibration only with standard G.652 SMF for arc calibration.
 - If the error persists or is limited to a particular splice mode, call the 24/7 support line at 1-800-235-3423, Opt. 3.

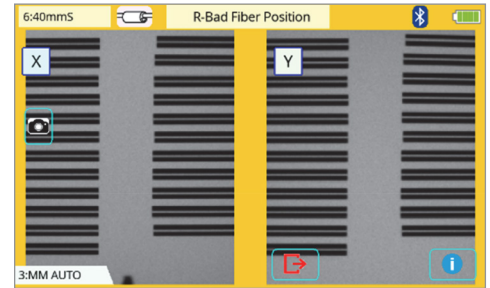
Figure 3

L/R Bad Fiber Position indicates the fiber is outside the field of view of the camera (*Figure 3*).

- Press [Reset] and then re-seat the fiber, ensuring it sits correctly in the bottom of the V-groove.

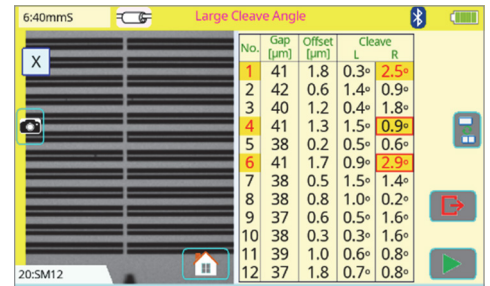
Figure 4

Large Cleave Angle indicates the angle of the fiber's end-face is larger than the threshold allowed by the current splice mode (*Figure 4*).

- Clean the cleaver pads and the cleaver blade, then try the cleave again – in most cases this will resolve the issue.
- Check the cleave count for that blade position. If it's at or close to 1250 cleaves, then the blade position is worn. Rotate the cleaver blade.
- Clean the camera lenses.

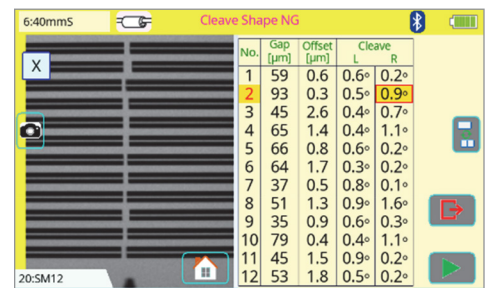
Figure 5

Cleave Shape NG means the end-face of the fiber is not flat and smooth (*Figure 5*).

- Clean the cleaver and re-prepare the fiber – in most cases this will solve the problem.
- If the cleaver blade is worn, rotate to an unused blade position.
- Clean the camera lenses.

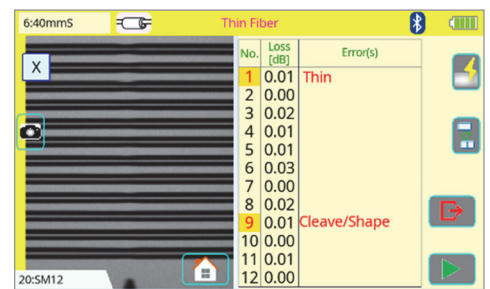
Figure 6

Thin/Fat/Too Tapering Fiber errors indicate the fiber is too thin, or fat, compared the splicer's standard for a quality splice (*Figure 6*).

- **Thin:** Most likely, the arc is too powerful, causing excessive melting that is not enough to fully separate the fibers
 - Perform an arc calibration with standard G.652 SMF and try the splice again.
 - If the error persists or is limited to one splice mode, call the 24/7 support line at 1-800-235-3423, Opt. 3.
- **Fat:** Generally, this is related to arc power as well.
 - Perform an arc calibration with standard G.652 SMF and try the splice again.
 - If the error persists or is limited to one splice mode, call the 24/7 support line at 1-800-235-3423, Opt. 3.

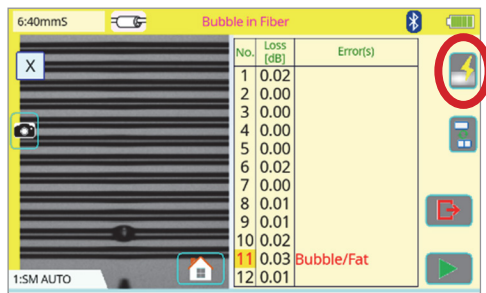
Figure 7

Bubble errors indicate a deformity is detected at the splice point, usually arising from contamination on the fiber end-face or from a bad cleave shape.

- A true bubble will appear as a dark circle at the splice point. Verify it is a bubble by pressing the **Re-Arc** button after the splice. If the occlusion changes or the spot grows, then it is a bubble. Break and re-splice (**Figure 7**).
 - Be sure to follow the proper “Strip, Clean, Cleave” preparation procedure. If the cleave shape is an issue, refer to the “Cleave Shape NG” section above.
- A Bubble error can sometimes arise when splicing highly multimode fibers, especially. This is the result of air becoming trapped in the glass as the two fibers begin to melt together. In this event, break and re-splice (see **red arrow** in **Figure 8**). This line does not affect splice loss, and the Bubble error can be handled by adjusting the “Bubble Sensitivity” setting in the splice mode.

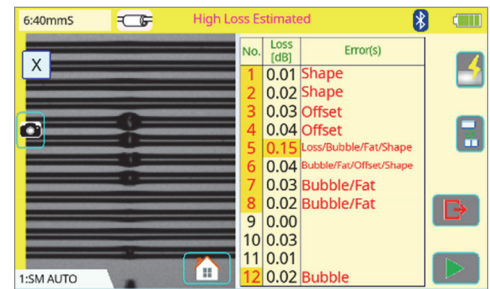
Figure 9

High Estimated Loss error could arise from many causes of this error, including the following (**Figure 9**):

- Improper fiber cleaning
- Bad fiber end face
- Bubble at the splice point
- Dust or dirt in the V-groove
- Dust or debris on the camera lens
- Bad electrode condition
- Uncalibrated arc power
- Incorrect splice mode
- Improper arc parameters
- Inadequate estimation parameters
