90R Splicer Error Code and Troubleshooting Quick Guide

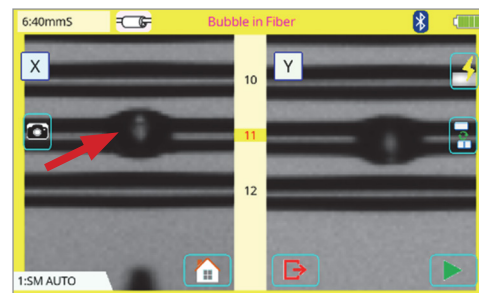
Figure 7

- A true bubble will appear as a dark circle at the splice point. Verify it is a bubble by pressing the **Re-Arc** button after the splice. If the occlusion changes or the spot grows, then it is a bubble. Break and re-splice (**Figure 7**).
 - Be sure to follow the proper “Strip, Clean, Cleave” preparation procedure. If the cleave shape is an issue, refer to the “Cleave Shape NG” section above.
- A Bubble error can sometimes arise when splicing highly multimode fibers, especially. This is the result of air becoming trapped in the glass as the two fibers begin to melt together. In this event, break and re-splice (see **red arrow** in **Figure 8**). This line does not affect splice loss, and the Bubble error can be handled by adjusting the “Bubble Sensitivity” setting in the splice mode.
